Vibration Monitoring of Gearboxes

James C. Robinson, Technical Consultant, IMI division of PCB Piezotronics

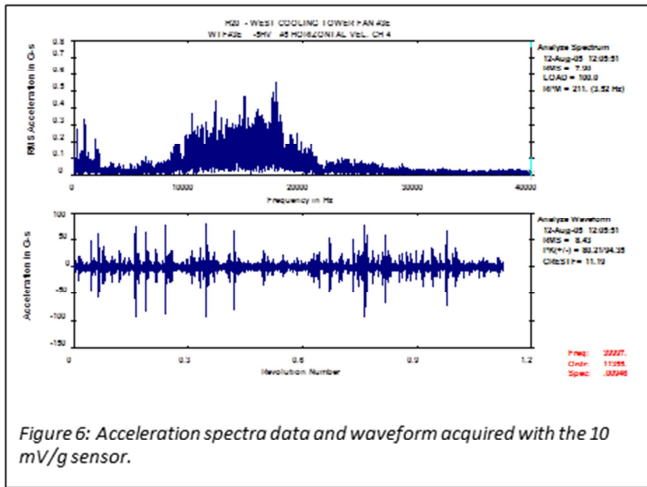
Figure 6: Acceleration spectra data and waveform acquired with the 10 mV/g sensor.

The accelerometer was replaced with a 10 mV/g accelerometer with a similar bias voltage. Using the 10 mV/g sensor, a 40 kHz acceleration spectra data set with waveform was captured and is presented as Figure 6. The peak-to-peak g-level was close to 200 g's, explaining why the 100 mV/g sensor's output was unstable. The primary cause of the high g-levels was friction occurring within the bearings as well as between the gear teeth as a result of an inoperable lubrication system driven by a gear oil pump.

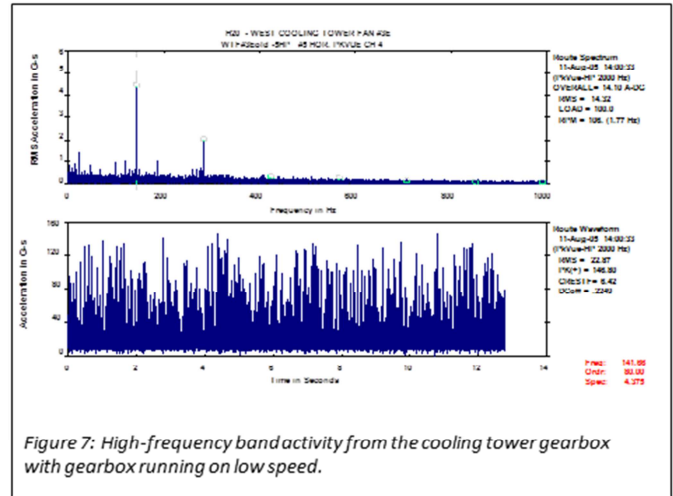
Figure 7: High-frequency band activity from the cooling tower gearbox with gearbox running on low speed.

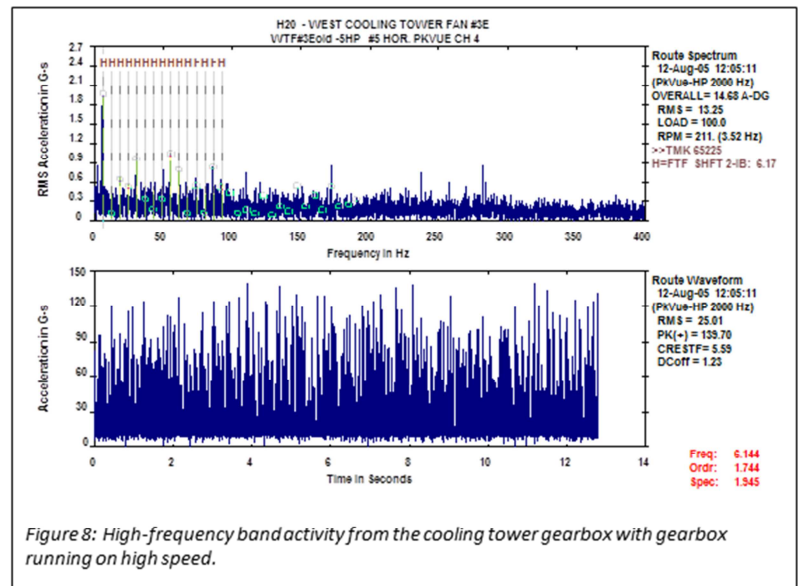
Figure 8: High-frequency band activity from the cooling tower gearbox with gearbox running on high speed.

The operators chose to continue operating the cooling tower rather than take the time to correct the lubrication problem. They did ask the analyst if it would be best to run the gearbox at high speed or at low speed. It was decided to run high-frequency analysis at both speeds to see if the best speed could be determined from the data. The high-frequency band chosen for the analysis was 2-40 kHz. The results for the gearbox running at high speed are presented in Figure 7. There was significant periodic activity at one and two times gear mesh frequency. The peak g-level in the waveform is 150 g's, which is very high. The results for the gearbox running at low speed are presented in Figure 8. The significant difference between the high-speed and low-speed activity is the lack of any gear mesh frequency or twice gear mesh frequency activity in the high-speed data relative to the low-speed data. The peak g-level in the high-speed data is 140 g's, which is slightly lower than the peak g-level of 150's in low-speed data. The presence of the gear mesh frequency and twice gear mesh frequency in the low-speed data suggests that debris from the friction between gear teeth was being thrown out into bearings. The conclusion was that there was sufficient oil in the bottom of the gearbox to permit the gear to sling oil out to lubricate the gear teeth when running at high speed. Therefore, it was decided that less damage would occur with the gearbox running at high speed. The gearbox was run at high speed until replaced with the new gearbox.

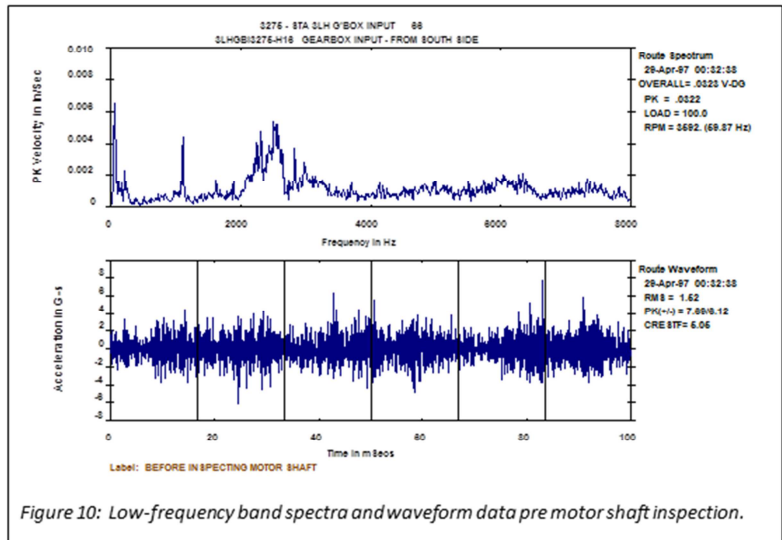
The low-frequency band spectra and waveform data are presented in Figure 10. The peak-to-peak g-level in the waveform data is about 14 g's. There is definite periodic activity around 1,000 Hz. There are probably two individual gear mesh frequencies in the expected frequency range of 2,100 to 2,300 Hz. Additionally, there is a broad band of spectra activity in the 2,500 to 2,800 Hz frequency range. The high-frequency (5 to 40 kHz) rectified waveform and spectra data taken at the same time as the low-frequency band data are presented in Figure 11. The spectra bandwidth of the high-frequency data in Figure 11 was specified at 1,000 Hz, which was an oversight. It should be slightly greater than twice gear mesh frequency (5 kHz). The peak g-level in the rectified waveform is about 8 g's. The bothersome feature of concern in the high-frequency spectra data in Figure 11 is the activity at slightly greater than 0.5 times running speed. It is an indication of a possible torsional resonance. Based on this observation, it was decided to inspect the motor shaft/key. A picture of the motor shaft/key is presented in Figure 12. There

Figure 10: Low-frequency band spectra and waveform data pre motor shaft inspection.

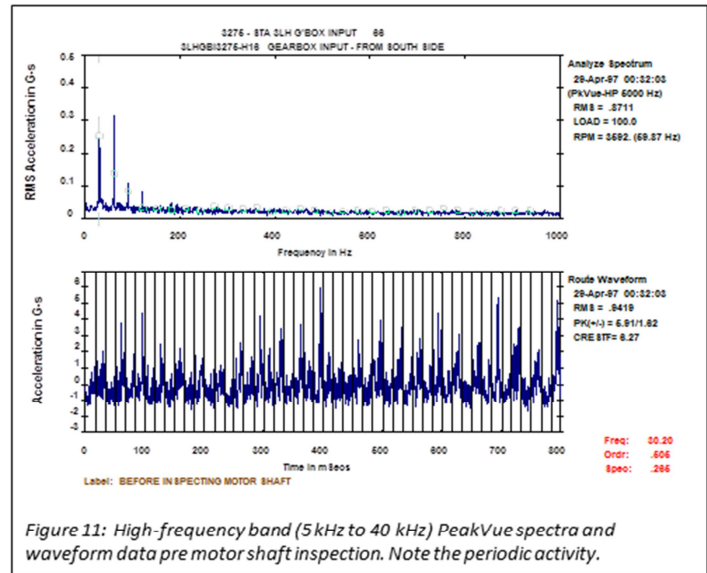
Figure 11: High-frequency band (5 kHz to 40 kHz) PeakVue spectra and waveform data pre motor shaft inspection. Note the periodic activity.

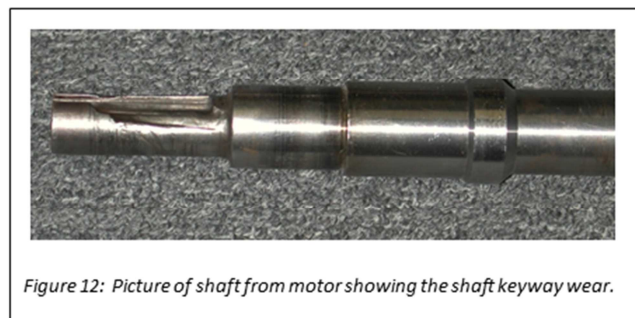
Figure 12: Picture of shaft from motor showing the shaft keyway wear.

has been considerable wear in the motor shaft keyway. The recommended solution was to decrease the tolerances in the keyway fit to the shaft. This corrected the shaft/key wear problem.

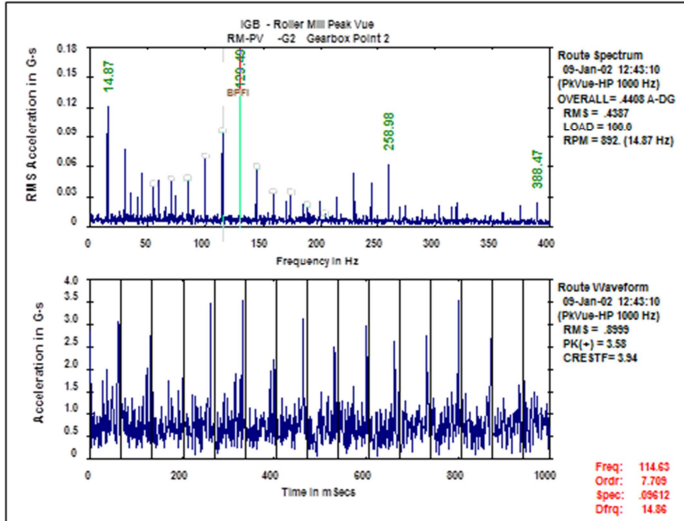
Routine monthly vibration data was acquired from all the measurements points on the gearbox. The high-frequency spectra data and rectified waveform from measurement point #2 are presented in Figure 16. The high-frequency band is from 1 kHz to 40 kHz. The 1 kHz is well above 2.25 times gear mesh frequency. (Gear mesh frequency is 330 Hz, which equals running speed of motor [15 Hz] times the number of teeth [22]). The bearing has an inner race fault in the early stages of failure based on relatively low peak g-level of 3.6 g's.

Figure 16: High-frequency, band-rectified waveform and spectra data taken on measurement point 2. Maximum peak g-level in waveform data is 3.6 g's.

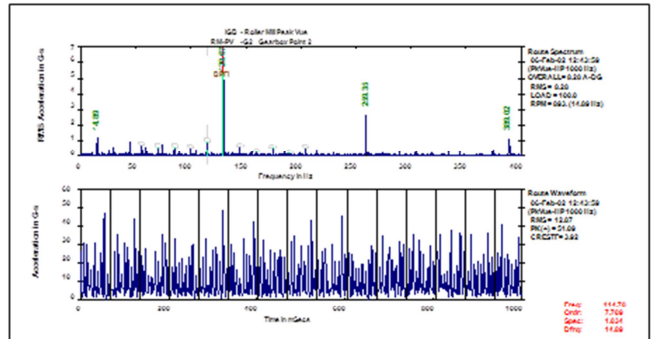
The measurement was repeated approximately one month later and results are presented in Figure 17. The big difference in Figures 16 and 17 is the peak g-level has increased from 3.6 g's to 51 g's, which is significant. This bearing, based on high g-level of 51 g's, requires frequent monitoring with a replacement plan set in motion.

Figure 17: High-frequency, band-rectified waveform and spectra data taken on measurement point 2 one month after the data taken and presented in Figure 16. The peak g-level in waveform data is 51 g's.

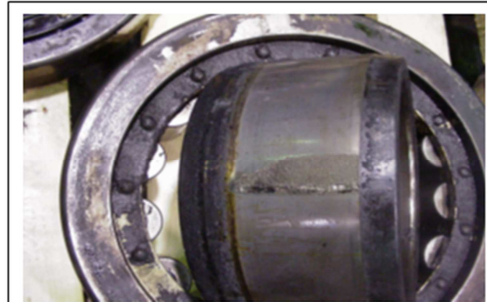
To assure the faulty bearing was bearing #3 and not bearing #1 or bearing #2, data was acquired from measurement point #1 at same time as the data in Figure 17 was acquired. The peak g-level in the high-frequency data from measurement point #1 was 25 g's versus the 54 g's from measurement point #2. The defective bearing was concluded to be bearing #3. Frequent monitoring with the sensor set on measurement point #2 was then carried out. The peak g-level trend is presented in Figure 18. From the time the 50 g peak level was detected, it took about 25 days to get the bearing replaced. A picture of the defective bearing is presented in Figure 19. The peak g-level recorded was about 80 g's.

Figure 19: Picture of the defective bearing showing inner race fault. This fault could have been introduced from bearing being stored in vertical position too long. Notice metal removal on inner race downstream of fault suggesting the rolling element was penetrating the oil film when jumping over the crack.

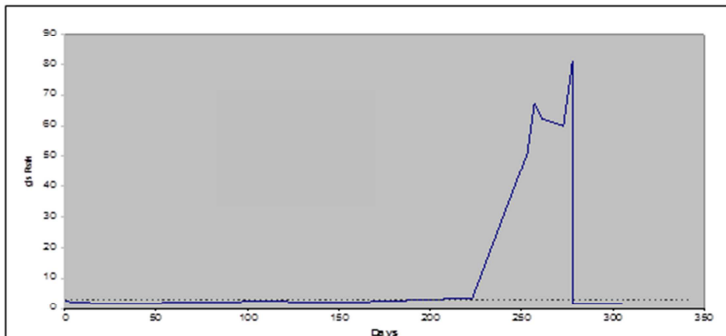
Figure 18: Peak g-level trend over an approximate 300-day monitoring period on measurement point #2.

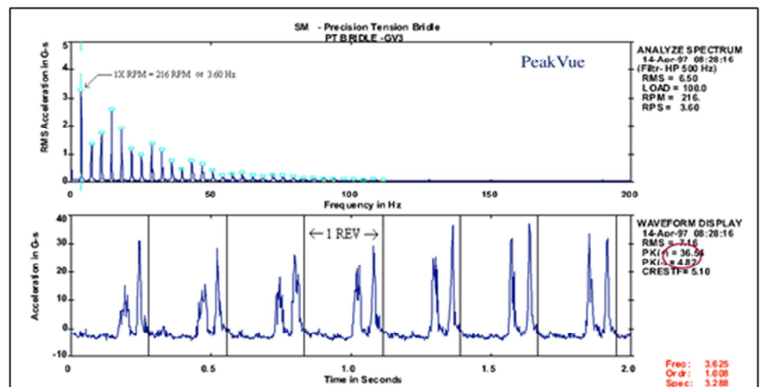
The spectra data indicates a significant event is occurring once per output shaft revolution. The waveform clearly demonstrates there are two distinct impulses per turn that could mean there are two cracks on one gear. When inspected, two cracked teeth on one gear were found.

Figure 22: High-frequency band from 0.5 to 40kHz rectified waveform and spectra data. The '1 REV' is for the slow dual shafts output. The spikes occurring once per revolution imply one of the 90 tooth gears has two cracked teeth.

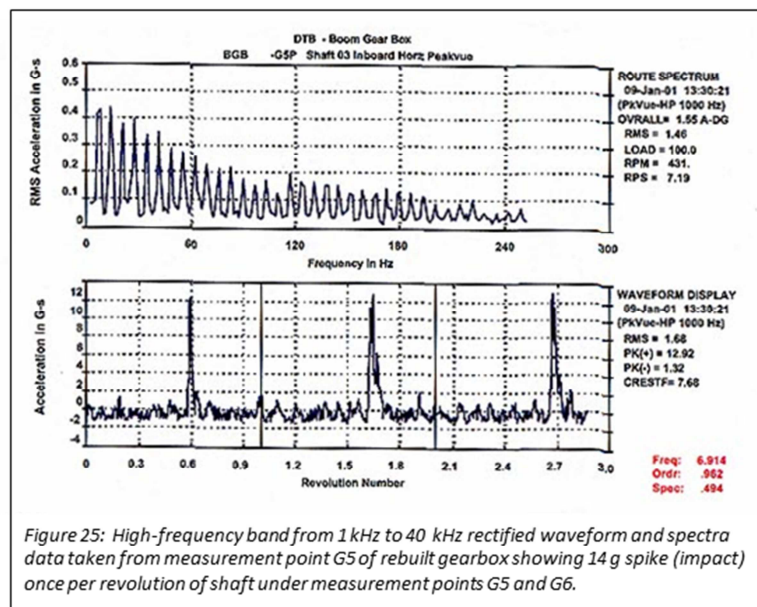
Figure 25: High-frequency band from 1 kHz to 40 kHz rectified waveform and spectra data taken from measurement point G5 of rebuilt gearbox showing 14 g spike (impact) once per revolution of shaft under measurement points G5 and G6.

The waveform and spectra data for the low-frequency band are presented in Figure 24. The peak-to-peak g-level in the waveform data is about 1.1g's, which is not considered to be indicative of a problem. The high-frequency band rectified waveform and spectra data are presented in Figure 25. There is a spike (about 14 g's) occurring once per revolution of the shaft immediately below measurement points G5 and G6. This is the expected signature from a cracked tooth in the gear immediately below measurement point G5. Upon inspection of this gear, it was found to have a crack in the root.

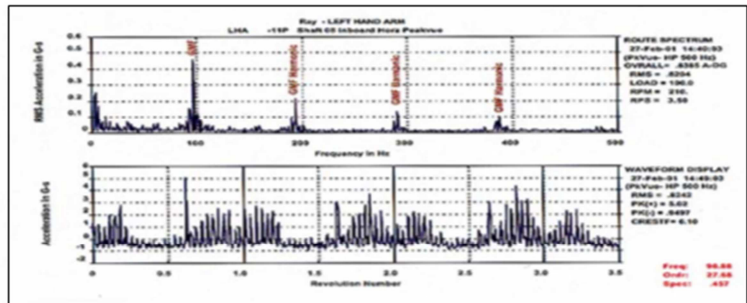
Figure 26: High-frequency band rectified waveform and spectra data from a completed rebuilt gearbox.

and low amplitude activity over the remaining 35% of the revolution. This is the pattern expected for an eccentric gear. In the spectra data, there is significant activity at gear mesh frequency, which is indicative of a stable rotational speed of the gear. Following replacement of the eccentric gear, the high-frequency rectified waveform and spectra were acquired and are presented in

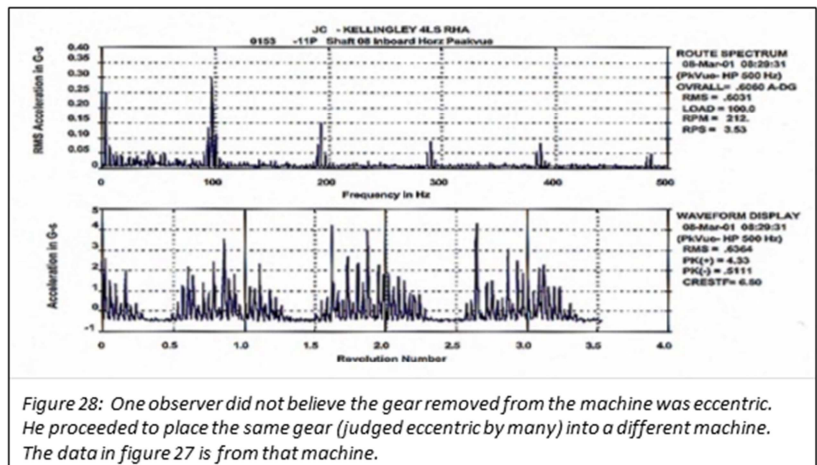
Figure 27. Someone was not convinced the gear was eccentric and placed the defective gear in another gearbox. When it was subjected to testing, the results presented in Figure 28 were obtained which was basically the same as that presented in Figure 26.

Figure 28: One observer did not believe the gear removed from the machine was eccentric. He proceeded to place the same gear (judged eccentric by many) into a different machine. The data in figure 27 is from that machine.

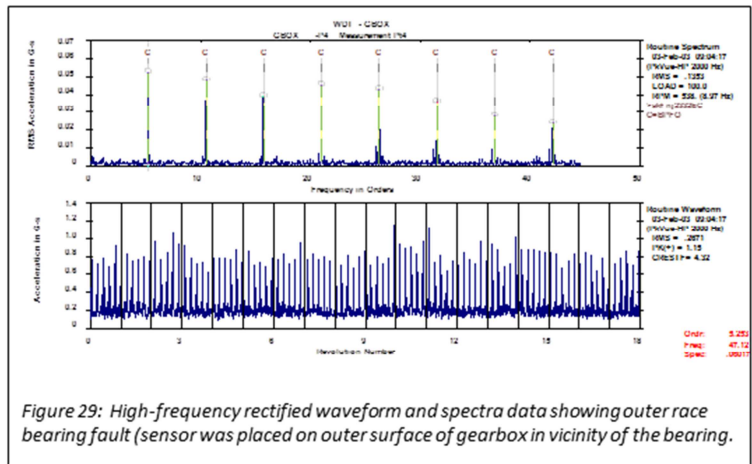
The rectified high-frequency band (2-40 kHz) waveform and spectra data are presented in Figure 29 from a sensor mounted over the outboard spur section of the gearbox. The spectra data is dominated by activity at 5.253 orders with many harmonics. This is the outer race fault frequency for the bearing used on the outboard end of the intermediate shaft in the spur gear section. The observed peak g-level of 1.15 g's for this speed shaft (538 RPM) is very low. The recommended alert level is 4-5 g's. This fault could very well be from the early stage fatiguing with cracking occurring under the outer race surface. The fault may not be visible if examined at this time by sight or by feel. Typically, wait until peak g-level reaches 6-8 g's (for this speed machine) before a plan is put in place for changing out the bearing unless there are special circumstances such as it is most economical to implement the change at this time.

Figure 29: High-frequency rectified waveform and spectra data showing outer race bearing fault (sensor was placed on outer surface of gearbox in vicinity of the bearing).

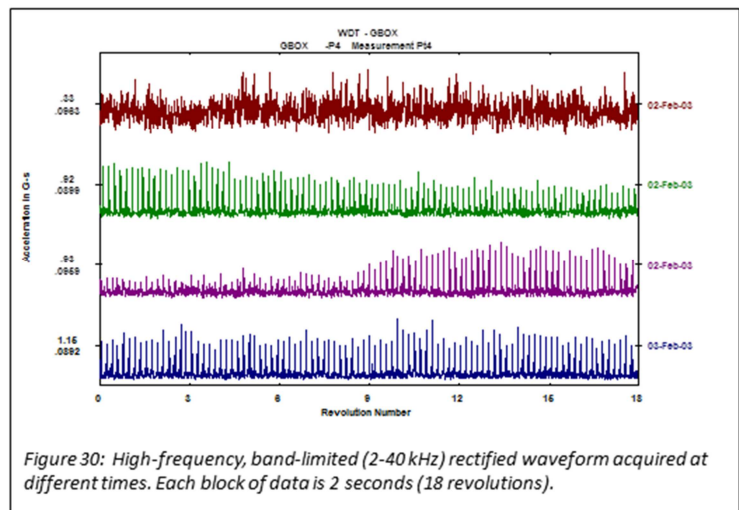
Figure 30: High-frequency, band-limited (2-40 kHz) rectified waveform acquired at different times. Each block of data is 2 seconds (18 revolutions).

The data in Figure 30 was chosen to illustrate how the fault signature can vary over reasonably short times. Each rectified time waveform is for a period encompassing 18 revolutions (2 seconds) of the intermediate shaft turning at 538 rpm. The last trace of data in Figure 30 is the same set of rectified waveform data presented in Figure 29. The three remaining data traces were acquired one day previous.

There is very little fault signature showing up in the first rectified waveform data. In the middle two traces of rectified waveform data, a fault signature is present but with considerable variability. If the signature was a result of impacting from a defect in the inner surface of the outer race, the rectified time waveform would not be expected to have the variability seen in Figure 29.
