Vibration Monitoring of Gearboxes

James C. Robinson, Technical Consultant, IMI division of PCB Piezotronics

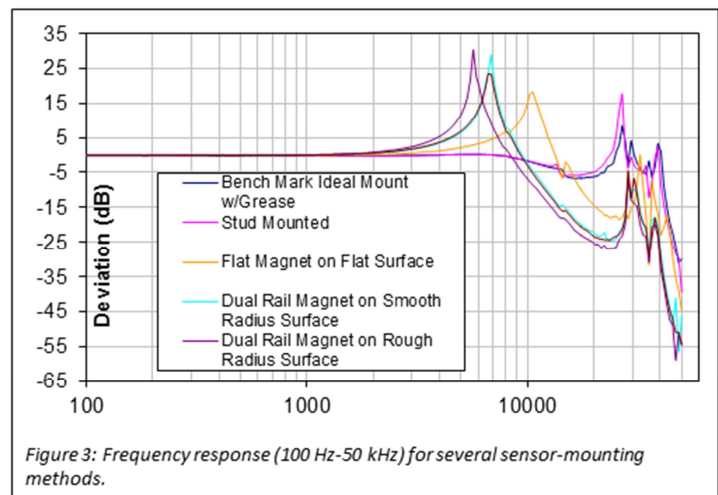
To explore the impact that sensor mounting has on the sensor frequency response, frequency response data was captured (presented in Figure 3) for a sensor that was:

For faults that manifest themselves in the frequency range of less than 2 kHz such as alignment, unbalance and looseness, the results would be independent of how the sensor is mounted. For faults identified with higher frequencies (impacting and friction), the results would be highly dependent to how the sensor is mounted ranging from no response to distorted response.

Of course, the best way to mount would be stud-mount with a specified torque. This could get expensive as it requires a dedicated accelerometer at every measurement point. An acceptable alternative mounting would be to use a flat magnet placed on a flat smooth surface such as a mounting pad. The flat magnet approach to all measurements points combined with stud mounting the sensor in radial direction on the inboard and outboard ends would be a recommended method for sensor mounting.

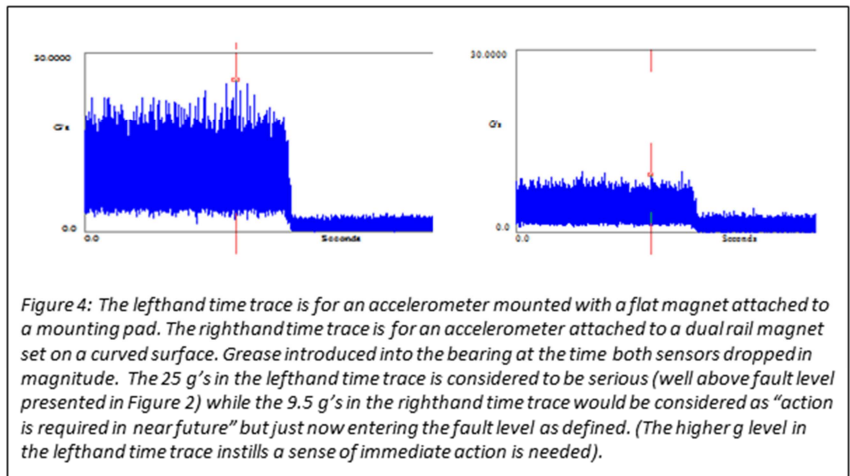
To illustrate the type of effect that sensor mounting can have on friction activity, data is presented in Figure 4 from a case where it was known that bearing lubrication was needed. In the lefthand time trace, the sensor was mounted using a flat magnet attached to a flat smooth surface. A second set of data on the righthand time trace was acquired from a sensor attached to a curved surface via a dual-rail magnet. Both time traces were taken at the same time using a two-channel data collector. The bearing was lubricated (greased) at the time the sudden level of noise decreased.

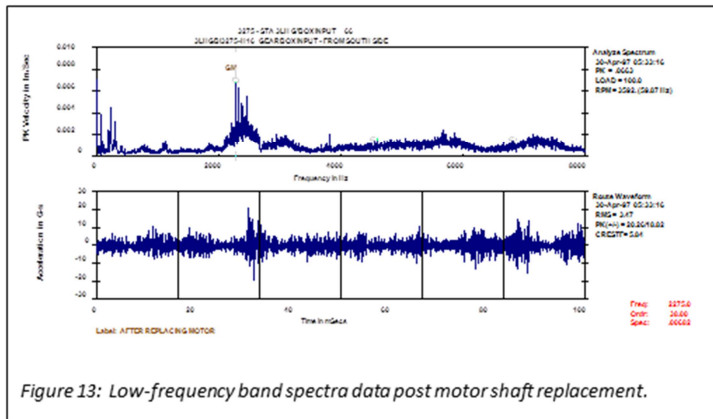
Figure 13: Low-frequency band spectra data post motor shaft replacement.

Spectra data taken after the motor shaft replacement is presented in Figures 13 and 14. The resolution is sufficient to clearly show the gear mesh frequency at 2,275 Hz as well as a probable torsional resonance at a frequency slightly greater than gear mesh frequency. The periodic activity that was seen in the high-frequency rectified waveform data before motor shaft change is gone. Additionally, the periodic activity that was seen at about 1,000 Hz in low-frequency spectra data before motor shaft change is also now absent. The most obvious change between the two sets of data is the significant increase in the vibration waveform amplitude. The peak-to-peak waveform in the low-frequency data went from 14 g's peak-to-peak to 40 g's peak-to-peak. A similar change occurred in the high-frequency rectified waveform. This is probably because the torsional stiffness increased with the tightening of the system at the motor shaft/key thereby increasing the torsional resonance frequency. The increase in vibration is more desirable than the shaft/key interaction.

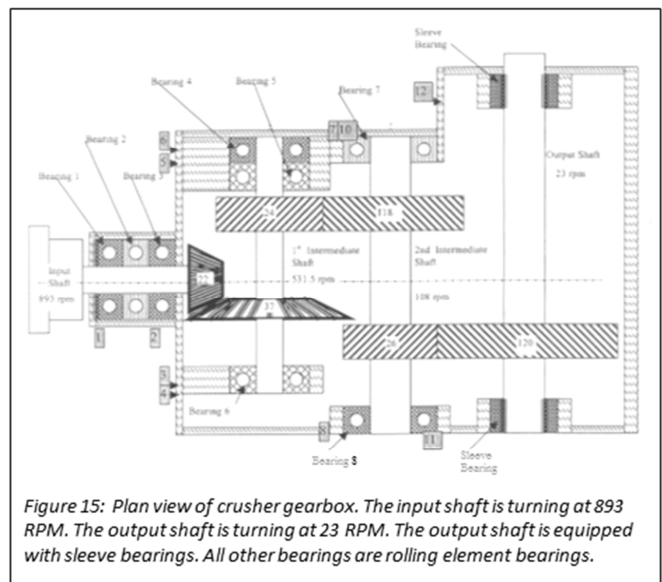
Figure 15: Plan view of crusher gearbox. The input shaft is turning at 893 RPM. The output shaft is turning at 23 RPM. The output shaft is equipped with sleeve bearings. All other bearings are rolling element bearings.

This is a large gearbox measuring roughly 8 x 10 x 20 ft used for crushing rocks at a mining facility. A plan view of the gearbox is presented in Figure 15. There are twelve vibration-monitoring points identified in Figure 15 as 1 through 12 which are used for scheduled acquisition of vibration data.

To assure the faulty bearing was bearing #3 and not bearing #1 or bearing #2, data was acquired from measurement point #1 at same time as the data in Figure 17 was acquired. The peak g-level in the high-frequency data from measurement point #1 was 25 g's versus the 54 g's from measurement point #2. The defective bearing was concluded to be bearing #3. Frequent monitoring with the sensor set on measurement point #2 was then carried out. The peak g-level trend is presented in Figure 18. From the time the 50 g peak level was detected, it took about 25 days to get the bearing replaced. A picture of the defective bearing is presented in Figure 19. The peak g-level recorded was about 80 g's.

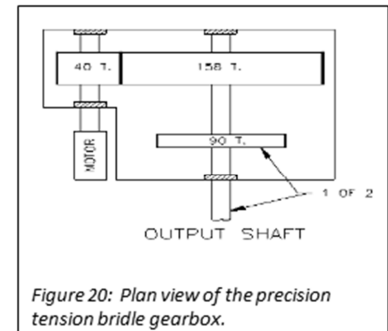
Figure 20: Plan view of the precision tension bridle gearbox.

A plan view of a precision tension bridle gearbox is presented in Figure 20. The gearbox has a single shaft input with a dual shaft output that ultimately drives the work rolls. The low-frequency and high-frequency band spectra and waveform data were taken with sensor placed over bearing at input to gearbox. The low-frequency band data is presented in Figure 21. The input gear mesh frequency (approximately 351 Hz with second harmonic) is being modulated. The lower gear mesh frequency (approximately 202 Hz) for the 90-tooth gear set is sharp (no indication of modulation) and the second harmonic is not discernible. The rectified waveform and spectra data for the high-frequency band of data from 0.5 to 40 kHz are presented in Figure 22.

The spectra data indicates a significant event is occurring once per output shaft revolution. The waveform clearly demonstrates there are two distinct impulses per turn that could mean there are two cracks on one gear. When inspected, two cracked teeth on one gear were found.

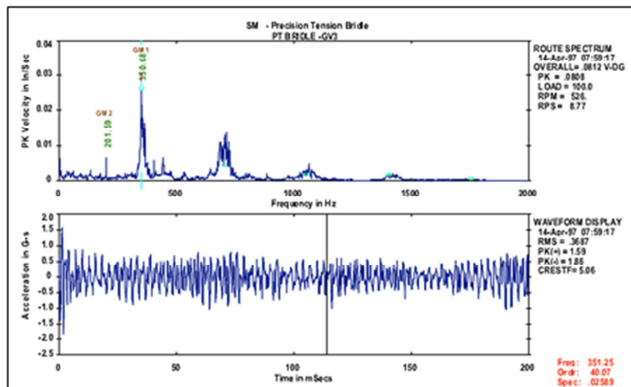
Figure 21: Low-frequency band spectra and waveform data taken from input shaft bearing housing. The most activity is from first and second harmonic of the input gear mesh frequency.

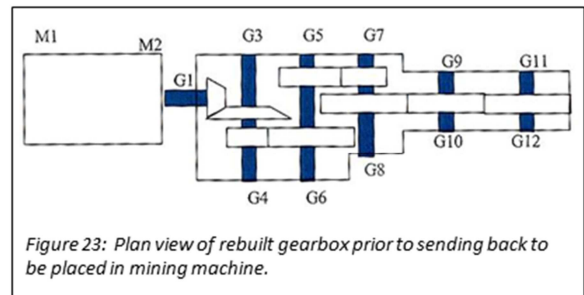
Figure 23: Plan view of rebuilt gearbox prior to sending back to be placed in mining machine.

A gearbox was removed from a mining machine and sent back to the shop for rebuild. A plan view of the gearbox is presented in Figure 23. This gearbox has four gear mesh frequencies. After the rebuild, the machine was subjected to vibration analysis for high and low-frequency bands prior to sending it back to the field. The vibration analyses are carried out on the twelve measurement points (as needed) identified on the gearbox as points G1 through G12. There is a measurement point placed over each bearing. In this case, focus is directed to the low-frequency band up to 1.5 kHz and the high-frequency band from 1 kHz to 40 kHz data from measurement point G5.

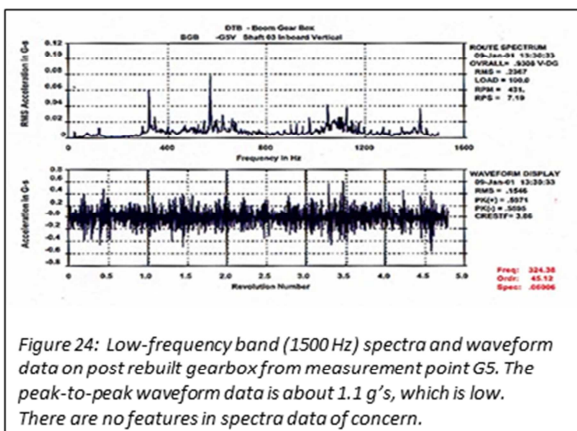
Figure 24: Low-frequency band (1500 Hz) spectra and waveform data on post rebuilt gearbox from measurement point G5. The peak-to-peak waveform data is about 1.1 g's, which is low. There are no features in spectra data of concern.

The waveform and spectra data for the low-frequency band are presented in Figure 24. The peak-to-peak g-level in the waveform data is about 1.1g's, which is not considered to be indicative of a problem. The high-frequency band rectified waveform and spectra data are presented in Figure 25. There is a spike (about 14 g's) occurring once per revolution of the shaft immediately below measurement points G5 and G6. This is the expected signature from a cracked tooth in the gear immediately below measurement point G5. Upon inspection of this gear, it was found to have a crack in the root.

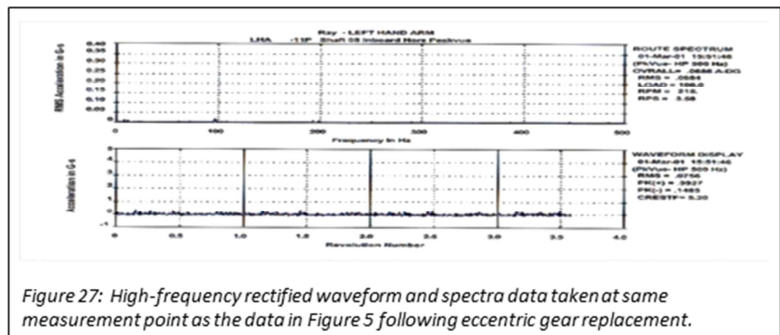
Figure 27: High-frequency rectified waveform and spectra data taken at same measurement point as the data in Figure 5 following eccentric gear replacement.

Figure 27. Someone was not convinced the gear was eccentric and placed the defective gear in another gearbox. When it was subjected to testing, the results presented in Figure 28 were obtained which was basically the same as that presented in Figure 26.
